J. D. Balsarini & Associates, Inc.
Summary Appraisal Report
ABC Construction Co., Inc.
February 29, 2015

**RE: FAIR MARKET VALUE AND ORDERLY LIQUIDATION VALUE SUMMARY APPRAISAL
OF CERTAIN EQUIPMENT AT ABC CONSTRUCTION CO., INC.**

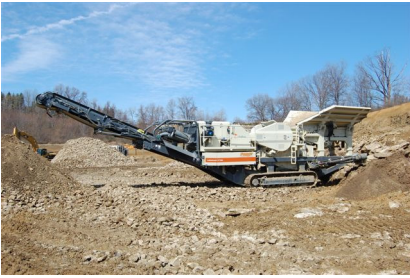
<u>Item #</u>	<u>Co. #</u>	<u>Description</u>	<u>FMV</u>	<u>OLV</u>
1.	A-1	2006 Metso LT-106 Track Mounted Portable Jaw Crusher, S/N 10002; CAT C9 diesel power, 8 yd. charging hopper, 13'x8"x3'7" feeder, Nordberg C106 28"x42" jaw crusher, extended discharge conveyor, 20" triple bar grouser pads x 14'6" crawlers, very good appearance, operational, 2,350 hours. Photo #1	\$ 00,000.00	\$ 00,000.00

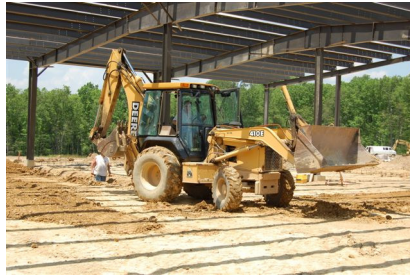
1.	C-1	1999 John Deere 410E 4x2 Loader Backhoe, S/N To410EX800005; John Deere diesel power, collarshift transmission, 92" wide GP loader bucket, EROPS cab, standard hoe plumbed for attachment, 24" hoe dipper, 12.5/80 front and 21Lx24 rear tires, good appearance and tires, operational, 4,393 hours. Photo #2	00,000.00	00,000.00
----	-----	--	-----------	-----------

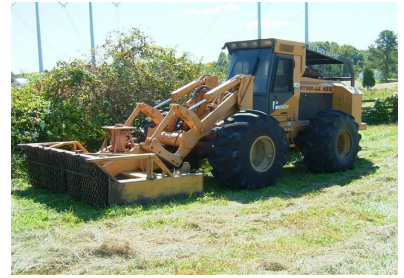
1.	F-3	1993 Hydro AX621E, S/N 5759; Cummins diesel power, 4WD, 621E brush cutter, EROPS cab, winch, 28L26 tires, good appearance and very good tires, operational, 7,250 hours. Photo #3	00,000.00	00,000.00
----	-----	---	-----------	-----------

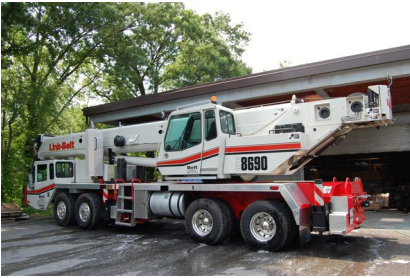
1.	L-1	2008 Link-Belt HTC-8690 90 Ton Telescopic Boom Hydraulic Truck Crane, S/N N4K9-8866HTCN4474; CAT C-13 12.5L 445 HP Tier III diesel power, ZF automated 12-speed transmission, 8x4 carrier, two (2) main hoists w/730' cable capacity, five (5) section 38' to 140' boom w/optional swing-a-way jib to 182', two (2) 16' built-in lattice boom sections to 214', a/c in both cabs, hoist monitors and safety systems, very good/like new appearance, operational, 380 hours and 1,273 miles. Photo #4	00,000.00	00,000.00
----	-----	--	-----------	-----------

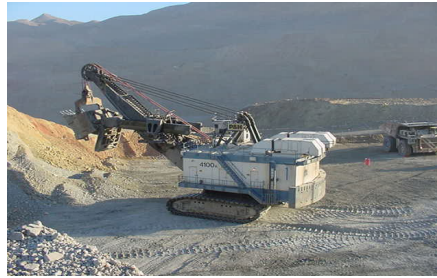
1.	M2	1997 P&H 4100A Electric Hard Rock Front Loading Shovel, S/N FT5265; electric power, Esco 56 cu. yard dipper on a standard loading front, 60" pads x 42'5" crawlers, good appearance and undercarriage, operational, 50,410 hours recorded on the meter and in the maintenance records. Photo #5	00,000.00	00,000.00
----	----	---	-----------	-----------

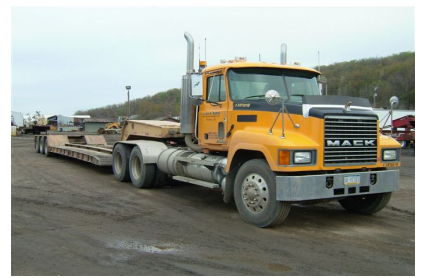
1.	T1	1994 Mack CH613 Tandem Axle Truck Tractor, VIN 1M1AA14X3SU00005; Mack 350 diesel power, Fuller 8LL transmission, wet line, sliding 5 th wheel, 12,000# front and 38,000# rear axles, 11R22.5 tires, aluminum budd wheels, good appearance and tires, operational, 329,500 miles. Photo #6	00,000.00	00,000.00
----	----	--	-----------	-----------

<u>Item #</u>	<u>Co. #</u>	<u>Description</u>	<u>FMV</u>	<u>OLV</u>
2.	T-12	1994 Talbert TDW-50-HRG-1-T1 Tri-Axle Lowboy 50 Ton Equipment Trailer, VIN 40FW5338S100000; detachable gooseneck, non-ground bearing, 24' deck, 12' over axles, 4 th flip axle, air ride, 255/70R15 tires, good appearance and tires, operational. Photo #6	\$ 00,000.00	\$ 00,000.00

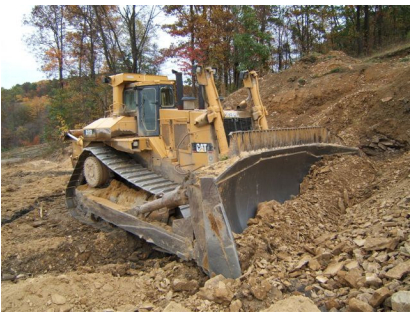
1.	ML1	1997 CAT D11R Crawler Tractor, S/N 8ZR75007 (certified CAT rebuild in September 2005); CAT diesel power, powershift, U-blade, twin tilt, EROPS cab/canopy, 27" single bar grouser pads, 4 BBL single shank ripper w/hydraulic pin puller, described as good appearance and undercarriage, operational, approximately 14,000 hours recorded and 4,500 hours since rebuild. Did Not View, Customer provided Photo #7	000,000.00	000,000.00

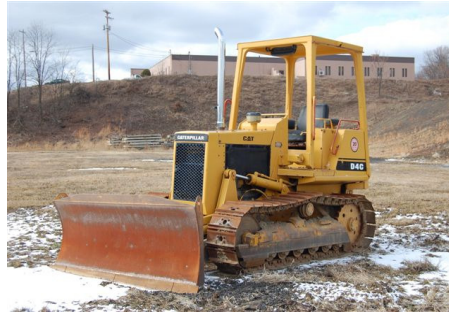
2.	ML2	1985 CAT D3B Crawler Tractor, S/N 27Y02075; CAT power, powershift, 6-way blade, OROPS canopy, drawbar, 16" single bar grouser pads, good appearance and undercarriage, 17,537 hours, parked for repairs in progress. Photo #8 (Shows D4 Decal)	000,000.00	000,000.00

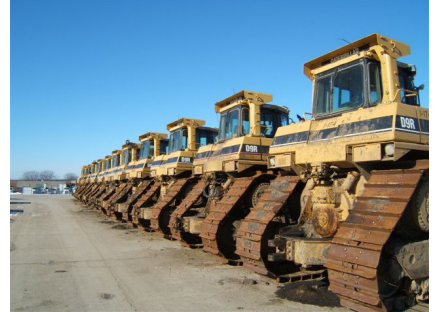
3.	ML3	Nine (9) 1986 CAT D9L Pull Tractors, S/N's all 14Y prefix; no dozer blades, EROPS cab/canopies, hydraulic packages, 30" pads, all good appearance and undercarriage, average 16,000 hours each. Valued at an average FMV of \$00,000.00 each and OLV of \$0,000.00 each. Value is for all nine (9) units. Photo #9	000,000.00	000,000.00

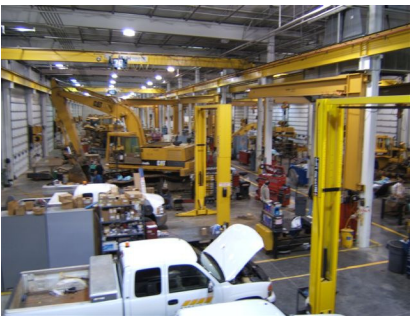
4.	ML4	Shop and Service Fleet Equipment Including: all hand held tools in shop and on service trucks, twelve (12) column mounted cantilevered high lift application jib hoists each with a 3 ton electric hoist and all other miscellaneous shop equipment; a 47 page inventory was reviewed, items were observed during our inspection, all looked good and operational. Bulk value for all of the above is conservative. Photo #10	000,000.00	000,000.00
